WORLD SAILING INVESTIGATION REPORT NACRA 17 INCIDENT

Prepared by: Kowalyshyn, Dina
Equipment Committee Chair

REVIEW OF NACRA 17 CLASS INCIDENT WITH SEVERE INJURY TO HAND

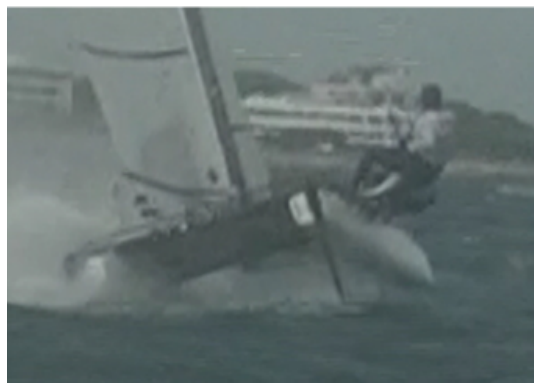
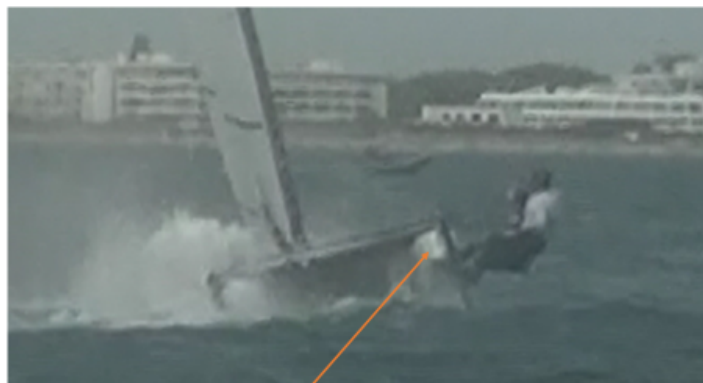
Figure D2 - Early in the Pitchpole

- b. The video shows that the leeward hull drops and digs into the water to initiate the pitchpole right at the offset mark. That action would be caused by an unbalancing of the boat at that time. The forces on the mainsail change as the mainsail controls are being eased as stated by the crew, increasing the force on the mainsail and moving the center of effort forward, and possibly up. This would cause a greater downward force on the leeward hull, and cause the bow down attitude the boat takes as it digs in and pivots around the leeward bow during the pitchpole. The helm is not clear on whether he moved the tiller to bearaway but it is assumed that he did. This also contributes to creating an unbalance in the boat.

Bearing away and going bow down

Both sailors still standing on side of hull, not under hull

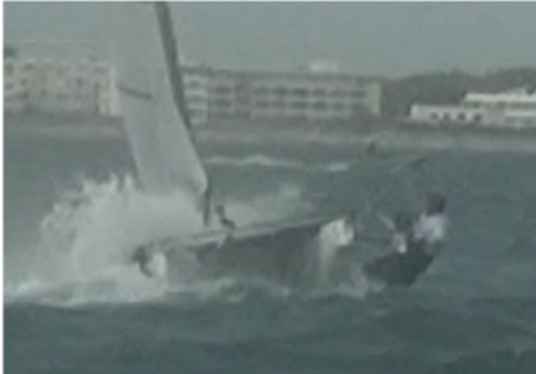
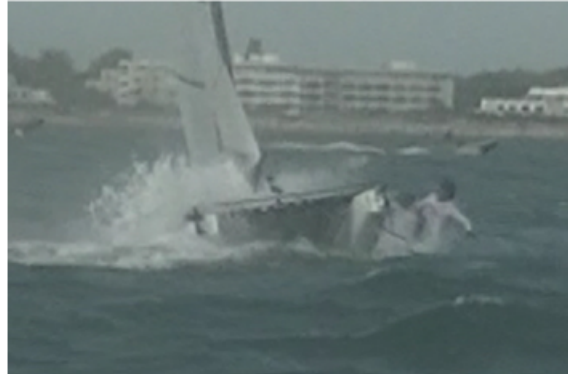
Figure D3 - Next Frames

Sailors still above the water, far away from hull

Looks like skipper is now outside of crew

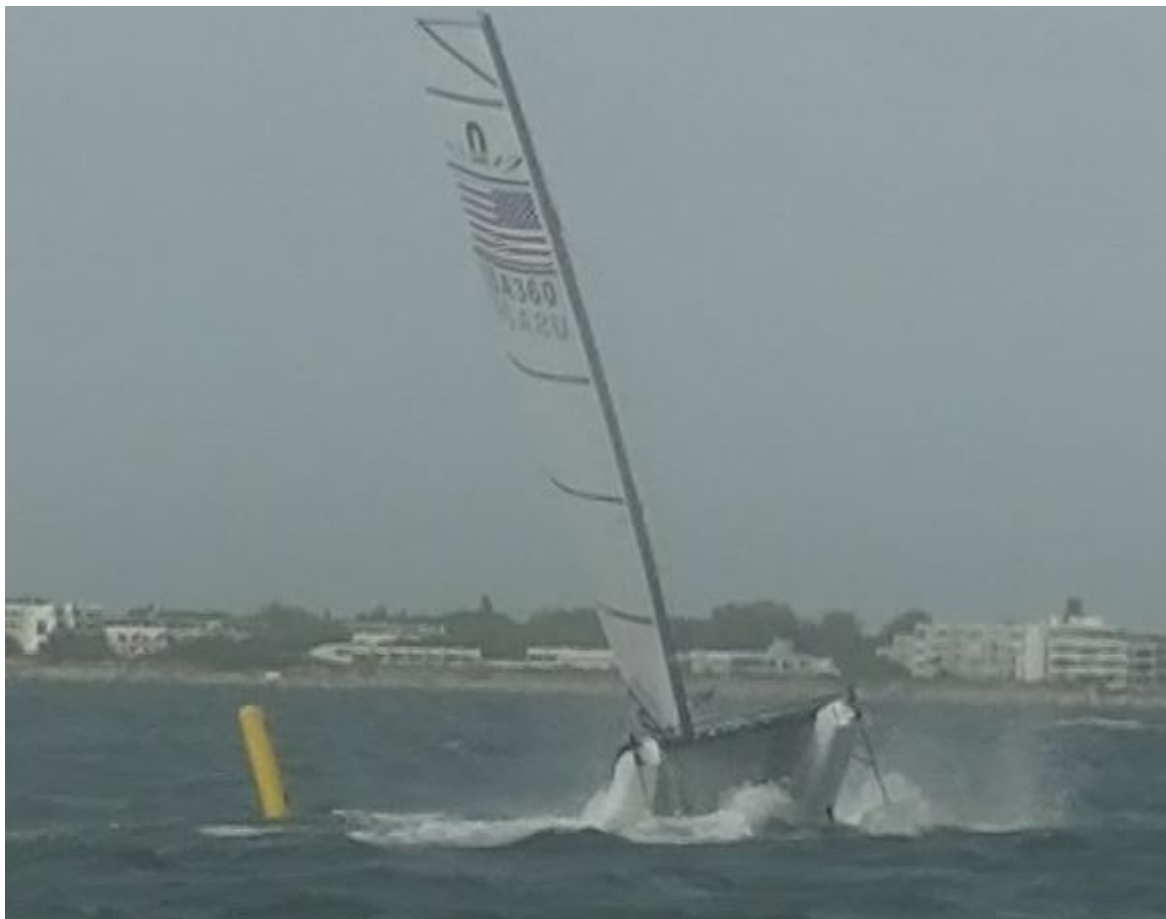
Figure D6 - Traveler Down (0:55)

- iv. The helm has identified the traveler line wrapped around his right hand as the mechanism of the injury. In watching the video it can be seen that the main is on centerline until second 0:55 of the video when it suddenly drops to leeward. The sailors are not visible at this angle but this tells us that the traveler line has come loose and we know both sailors are forward in the water.

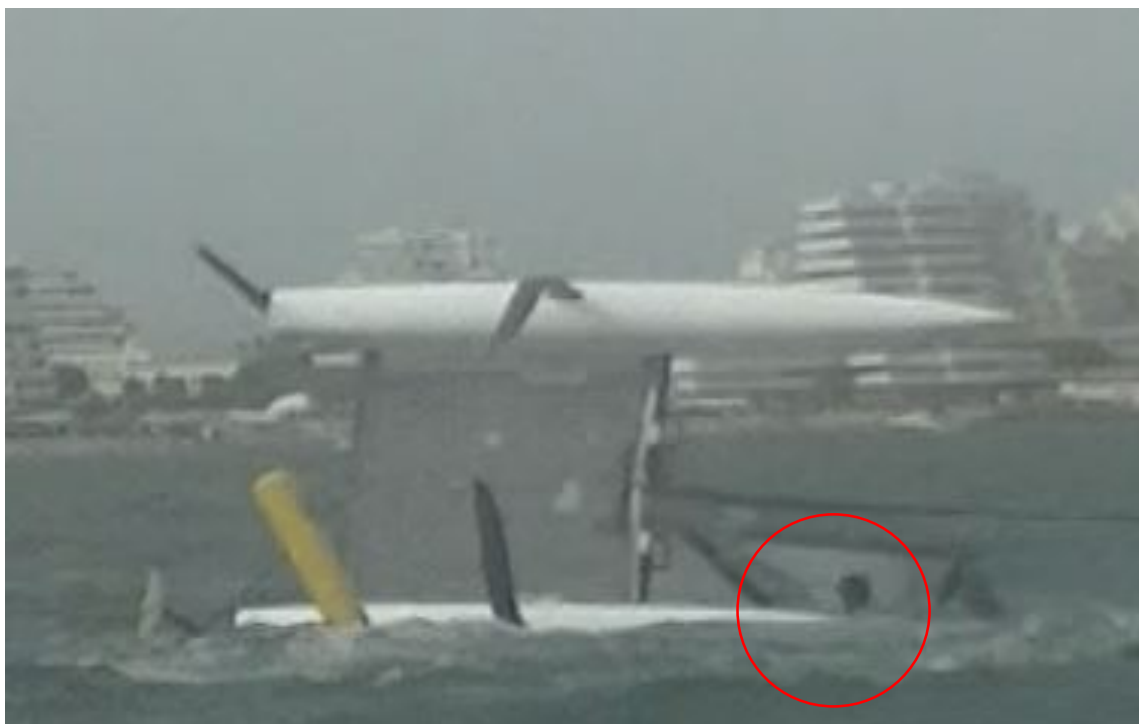
***Figure D7 - At 1:00 in the video
Sailor visible in the water***

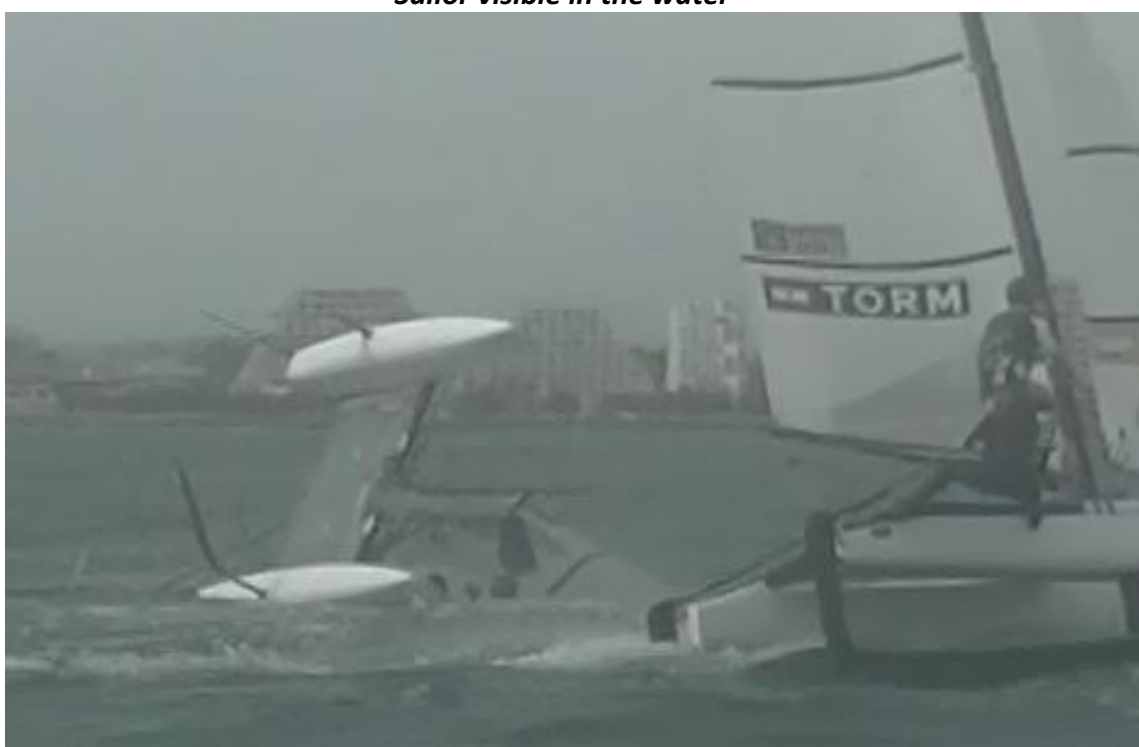
***Figure D8 - Still at 1:07
Sailor with hand raised out of water.***

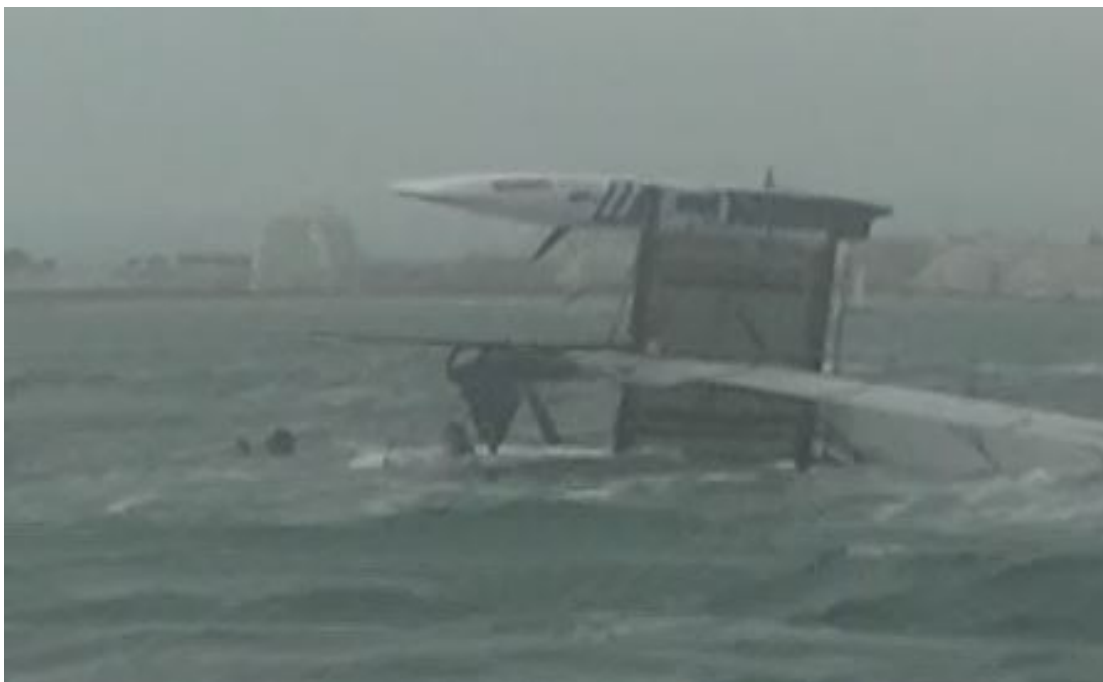
***Figure D9 – Still at 1:19
Injured Sailor with hand raised floating away from boat with crew close to boat***

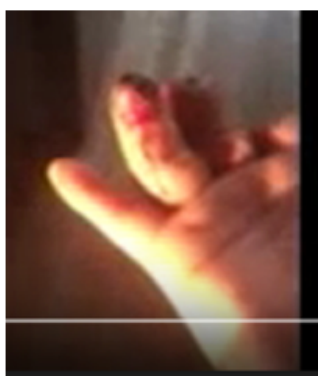
Figure D10 - Image of Right Hand After Amputation

These photos are approximately 3 weeks post injury. Note large abraded area of the ring finger. This finger was pinned By the Emergency Room Dr. Indicating that the finger was Broken during the accident.

- c. Personal Safety Equipment – Sailors should wear gloves that protect against cutting by thin lines and wire under load. These are commercially available at low cost. The standard these types of gloves are tested is based on cutting with a straight edge. There are no protection standards that apply to wrapping lines around a hand.
