# **Rolex Sydney Hobart Yacht Race 2024**

## **Review Committee Report**

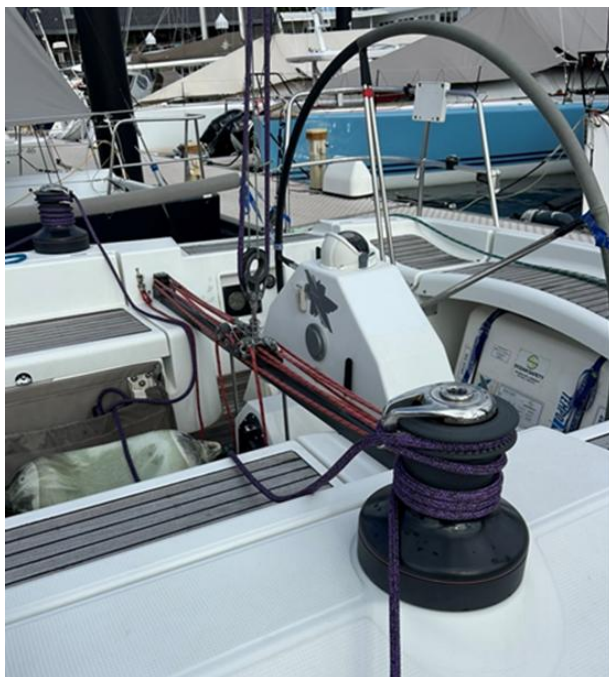
*The traveller and mainsheet winch arrangements onboard Bowline*

59. At 0200 the watch was changing and a decision was made to gybe the boat back to the rhumb line - from the starboard to the port tack. After the gybe, Nick Smith, 'the most experienced sailor onboard – having sailed two legs of the Clipper Round the World Yacht Race', was going off watch. For some unknown reason he decided to check the mainsheet traveller or possibly adjust the backstay as the boat settled down on its new course. Nick was on his knees on the cockpit floor forward of the mainsheet traveller. The boat was then hit by a cross sea possibly on the starboard quarter which forced the stern through the wind and the boat 'crash gybed' with the mainsail whipping across from the starboard to the port side. Nick was caught in the bight<sup>11</sup> of the mainsheet during the gybe and his chest was forced against the port mainsail winch with great force and catastrophic consequences.

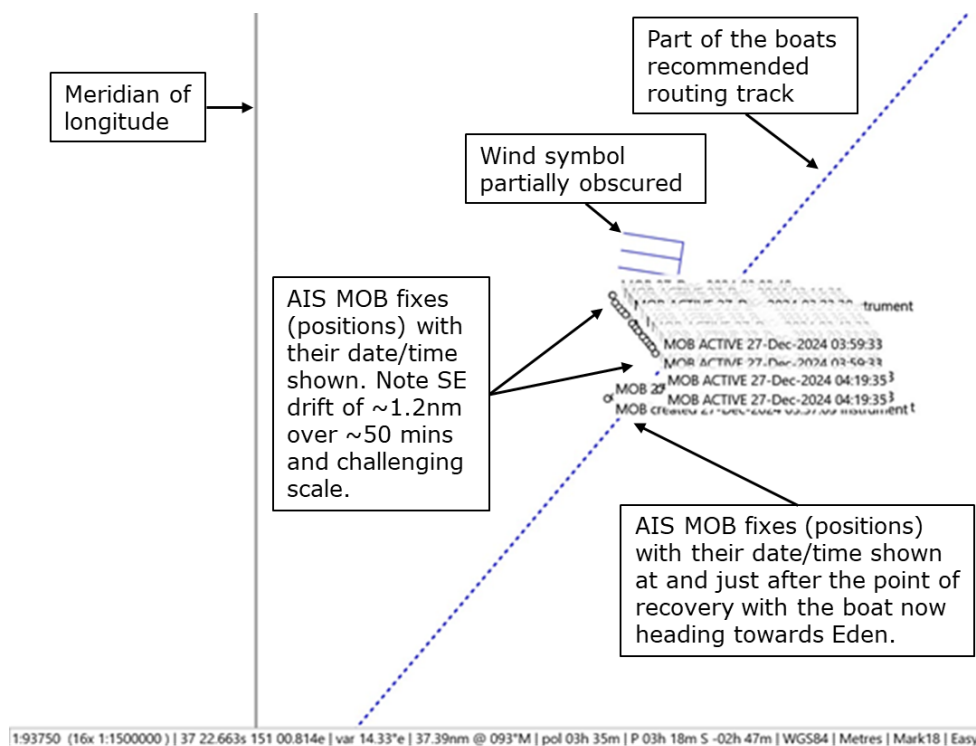
70. The navigator then detected an AIS MOB alert on the Expedition Routing Software installed on the laptop at the nav station. The AIS alert gave a fix but did not provide a range and bearing to the fix so he calculated the range and bearing roughly using a cursor, made more difficult because the only chart available in that area was small scale. At 0311 there was a further message from the Race Operations Centre that AMSA had detected Luke’s PLB. This message was passed on deck only to find that Luke was not on board and the situation was a real MOB. The identification of a name associated with the beacon was a vital piece of information. Fortuitously, the delay in identifying the true situation did not add any delay to the recovery.

*Annotated screen shot of what was presented on the Navigator's laptop*

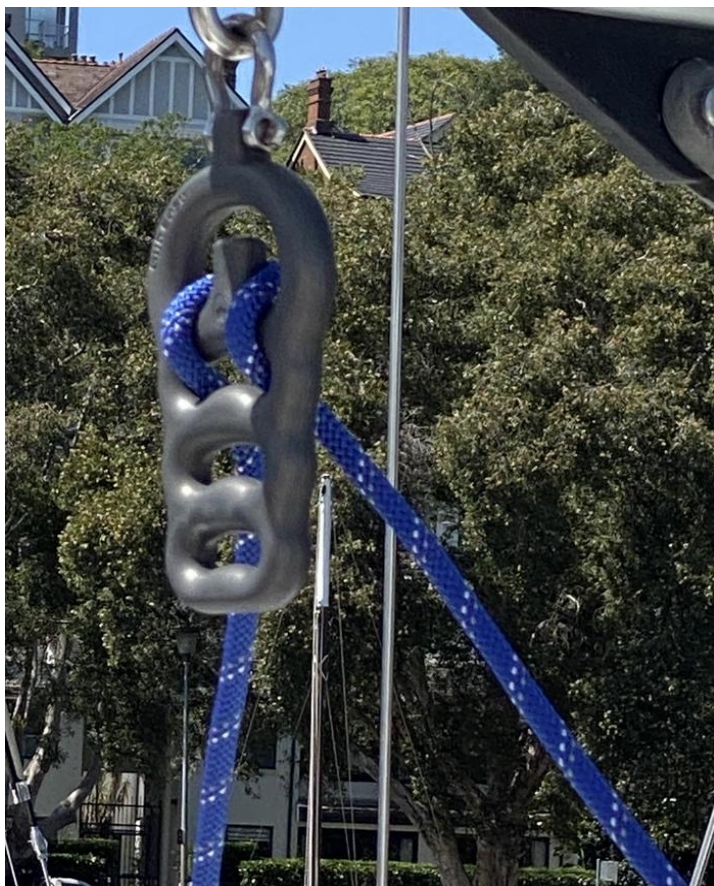
**Wichard Gyb'Easy Boom Brake – Rumchaser**

178. *Bowline* had investigated the option to use a boom brake several years ago when the boat was purchased but was not able to find one suitable for the boat. *Rumchaser*, a J/122e two hander, had a "Gyb'Easy' boom brake system installed that ran through a semi-rigid carabiner on the boom, immediately aft of the vang, and led back to the helm on either side of the boat for easy adjustment.
