# **Rolex Sydney Hobart Yacht Race 2024**

## **Review Committee Report**

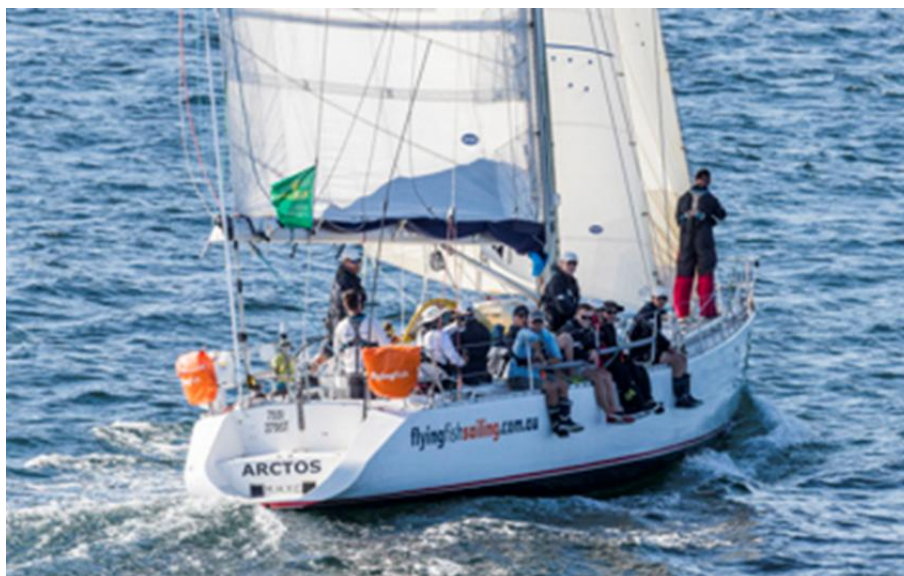
49. The crew member considers the incident was not weather related as they were experiencing 25 - 30 knots of winds - normal sailing conditions. Although the situation was compounded by a dark night with a confused sea. The crew member considered the sea state was still OK - ‘a relatively smooth ride, not on the edge of a gybe’. The crew member did not consider the boat overpowered - ‘but this might have been different for the helmsman’. A boom brake was fitted and on all the time but something went wrong. They did not know if it was reset properly

53. With respect to the incident the critical questions remain: what caused *Flying Fish Arctos* to 'crash gybe' and injure Roy? Other crew members might be able to assist with these questions.

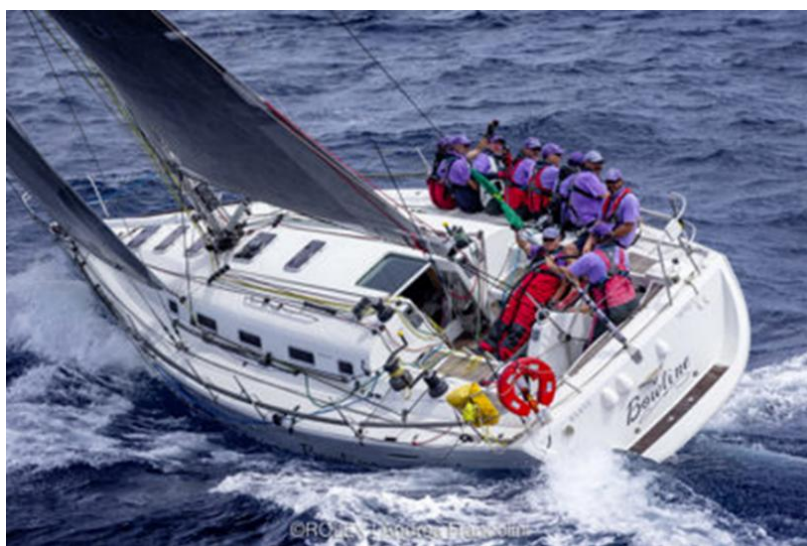
**Bowline**

56. Following the race start the crew enjoyed a fast run down the NSW coast sporting a new slightly smaller and heavier spinnaker specifically purchased for the race. Just on dark the spinnaker sheet clip failed and with the wind speed of about 31-32 knots it was decided to drop the spinnaker. During the night as the breeze freshened they put the first reef in the main and later a second reef. The headsail was not particularly useful and was flogging. At 2200 the headsail was dropped and the boat was sailing with just a main with two reefs.

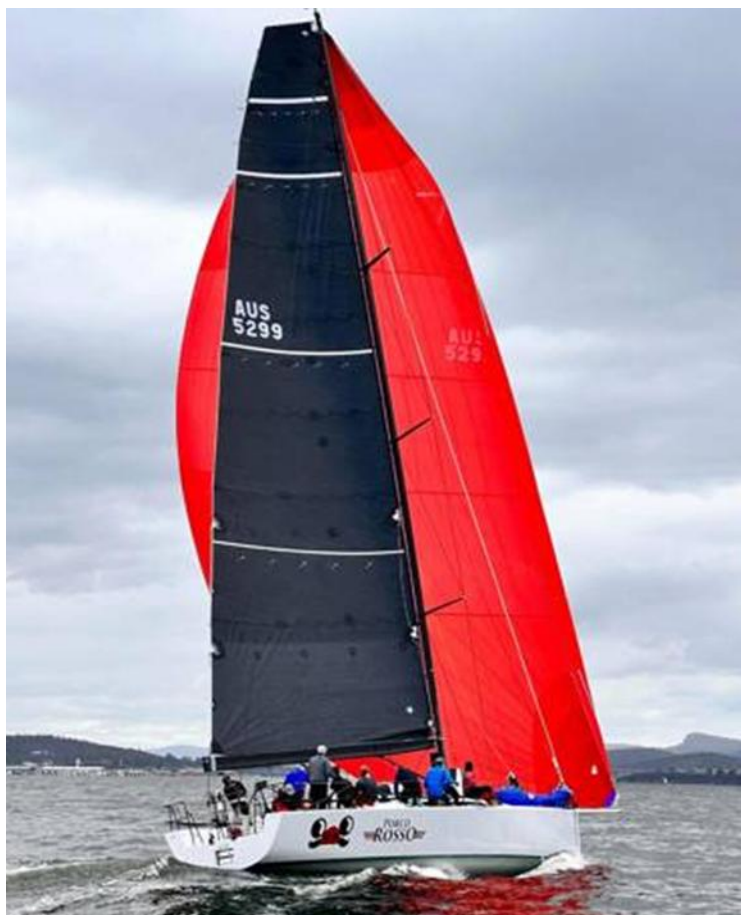
66. Although the boat was under control it was a challenging sail. There was no moon, pitch black with no visual reference – ‘one of the most disorientating nights sailing I have experienced’. It was really hard work steering the boat with the lack of visible reference and very confused sea – ‘difficult to judge if you were high or low’ – ‘every now and then we would get a wave on the side’ - ‘the instruments weren’t a great help because of the lag’. The race two years before was recalled as a hard run at night down the Tasmanian coast with probably a bigger sea but with the benefit of a moon made the sail far more manageable. As *Porco Rosso* passed Green Cape, they were well to seaward, the wind was backing to the west at about 345<sup>0</sup> - 350<sup>0</sup> and they were sailing fast towards Hobart on the starboard tack.

71. Shortly before the ‘crash gybe’ Luke Watkins had come on deck for the change of watch. Earlier that evening during his previous watch his lifejacket had inadvertently inflated. Before coming on deck for his next watch he replaced his expended lifejacket with the spare required to be carried by the regulations (ASSR). Even though the Spinlock vests are promoted as being resistant to inadvertent activation the crew had experienced five such activations since the start of the race - a result of sailing the boat hard and a lot of water across the deck.

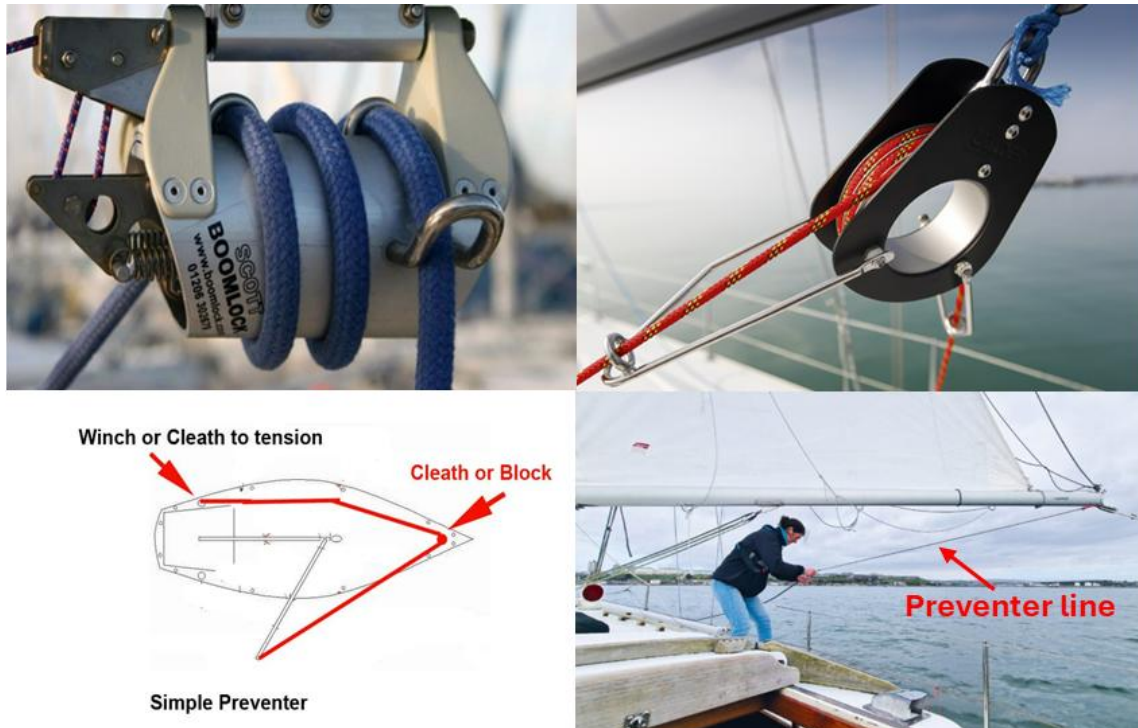
98. Boom brakes can offer some initial slowing of the unintentional boom movement thus providing some warning time before an impending 'crash gybe'. There are practical size limitations of the size of mainsail that can be controlled. Adequate braking effect can be difficult to achieve with the size of the booms in mid-sized to large yachts with the associated forces. Both devices, preventers and boom brakes, can provide a pause on the point of an unplanned gybe that may be caught in moderate conditions to prevent the gybe. In any event the boom brake is designed to slow the boom's motion and make an unplanned gybe less dangerous. Both restraining systems can be used in a variety of wind conditions and situations from holding the boom in position in very light winds and sloppy seas to preventing the boom freely crossing the boat in strong winds and large seas (a 'crash gybe').

***Top – Boom brakes are friction-based mechanical devices affixed to the boom and controlled by a line while,***

***Bottom – Preventers typically comprise a line rigged at the end of the boom and led forward.***
